A Case Study of a Large Unstable Mass Stabilization: “El Portalet” Pass at the Central Spanish Pyrenees

Abstract: This case study presents the engineering approach conducted for stabilizing a landslide that occurred at “El Portalet” Pass in the Central Spanish Pyrenees activated due to the construction of a parking lot. Unlike common slope stabilization cases, measures projected here were aimed at slowing and controlling the landslide, and not completely stopping the movement. This decision was taken due to the slow movement of the landslide and the large unstable mass involved. The degree of success of the stabilization measures was assessed by stability analyses and data obtained from different geotechnical investigations and satellite survey techniques such as GB-SAR and DinSAR conducted by different authors in the area under study. The water table was found to be a critical factor in the landslide’s stability, and the tendency of the unstable slope for null movement (total stability) was related to the water table lowering process, which needs more than 10 years to occur due to regional and climatic issues. Results showed a good performance of the stabilization measures to con

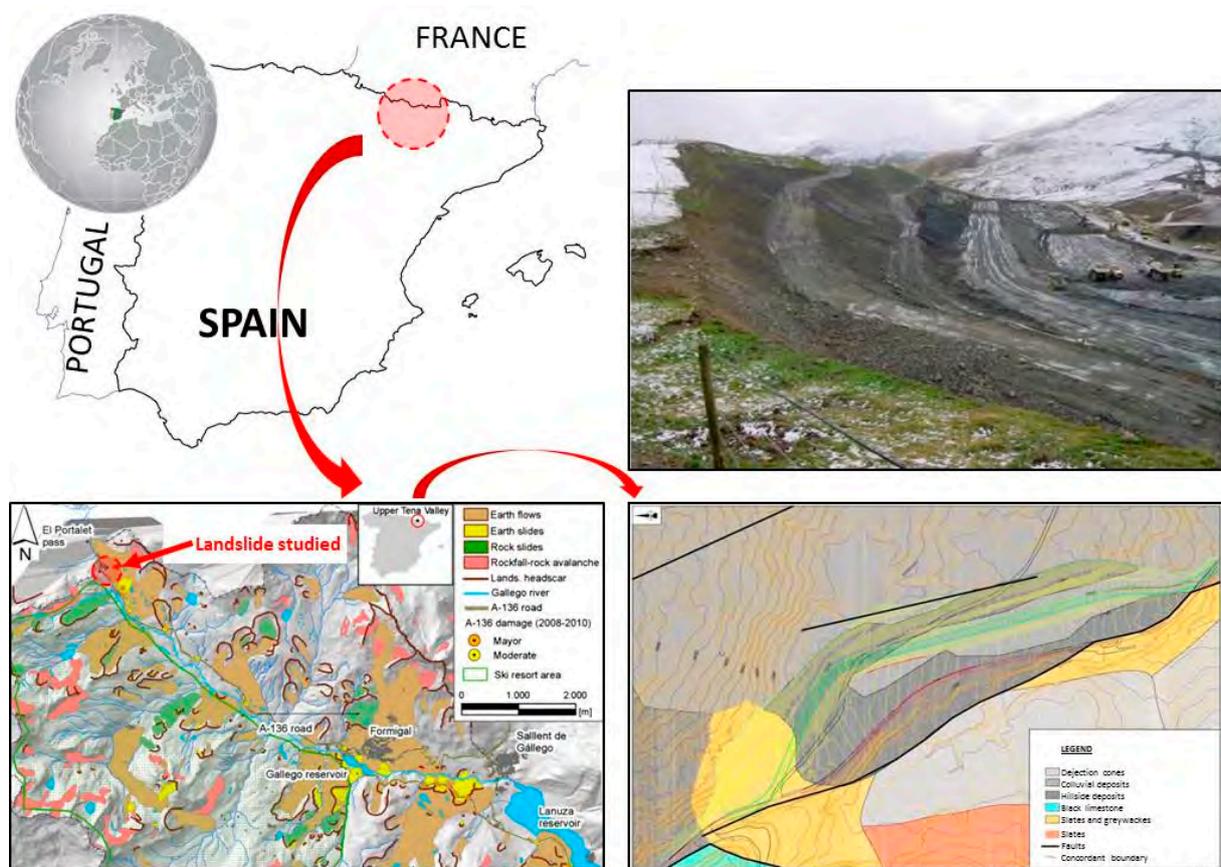
Figure 1. Geographical and geological setting of the area under study in the Central Spanish Pyrenees and view of the parking excavation works (note: bottom left image modified from [22]).

One of these slumps was mapped by García Ruiz [16,17]. Two parallel tension cracks, which form successive steps (see Figure 1), match the southern slope of the Petrusos spurs and they also overlap with the convex surface presented by the rocky hillside. At its toe, the slumps can be found with two coalescent lobes that reach the fracture northwest of the sunken block of “El Portalet”. The high density of such morphologies can be found on the Gallego head of the slope, especially between “El Portalet” and Formigal ski station in addition to the Peña Foratata southwestern slope, where superposed landslides tend to form great slumps. Most of them do not look very active, but other slumps are still moving or show a local reactivation.

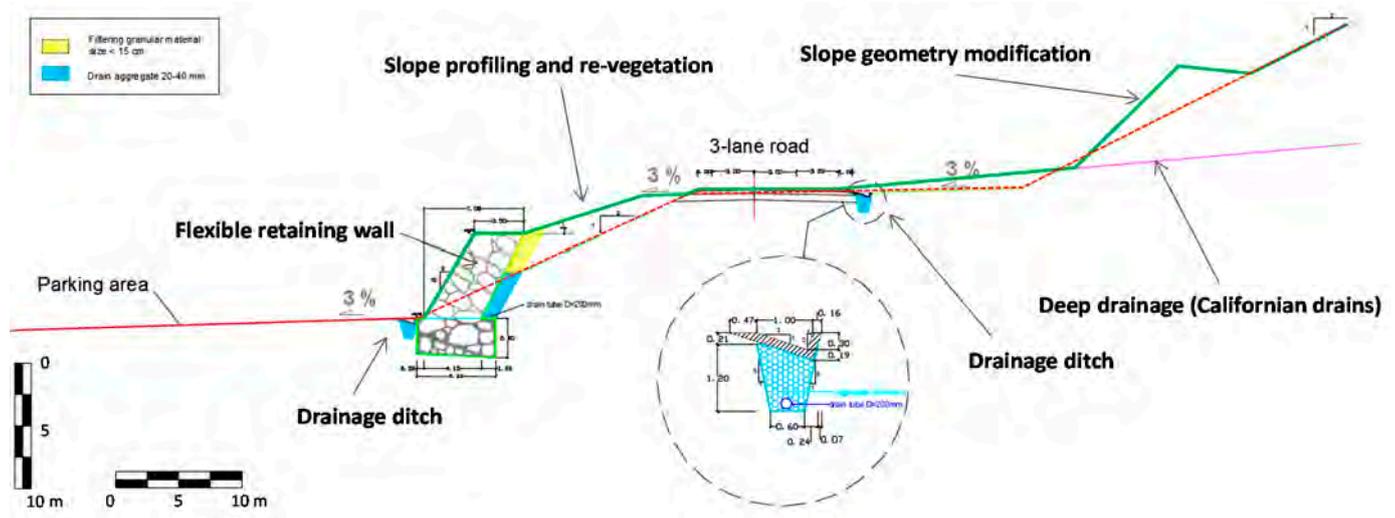
Figure 3. Stabilization measures projected; red dotted line and green line show the slope profile before and after implementing the stabilization measures (highlighted in bold), respectively.

A series of corrective measures were proposed to be performed on the slope to stabilize the landslide. Those measures (Figure 3) were not aimed to stop the hillside movement immediately and absolutely but to slow it down and prevent any damage to surrounding infrastructures. Eventually, the measures projected were expected to completely stabilize

- A slight modification of the slope geometry by means of the excavations of intermediate areas (benches) on the slope.
- Installation of deep drainage measures (Californian drains) as well as ditches to improve slope drainage and remove water coming from seepage and runoff; in total, 47 single drains were installed with a separation of 15 m; the horizontal slope was 6% following Serrano and Gómez [29] and Forrester [30]. Drains were executed with slotted PVC pipes with a thickness of 1.5 mm and a diameter of 75 mm.
- Implementation of slope conservation and stabilization measures such as slope profiling and re-vegetation.
- Performance of a flexible retaining wall at the slope toe; wall height was 6 m from the ground and 9.2 m from the bottom of the foundation and its width was found between 3.5 and 4.1 m; its vertical slope was 6:10.

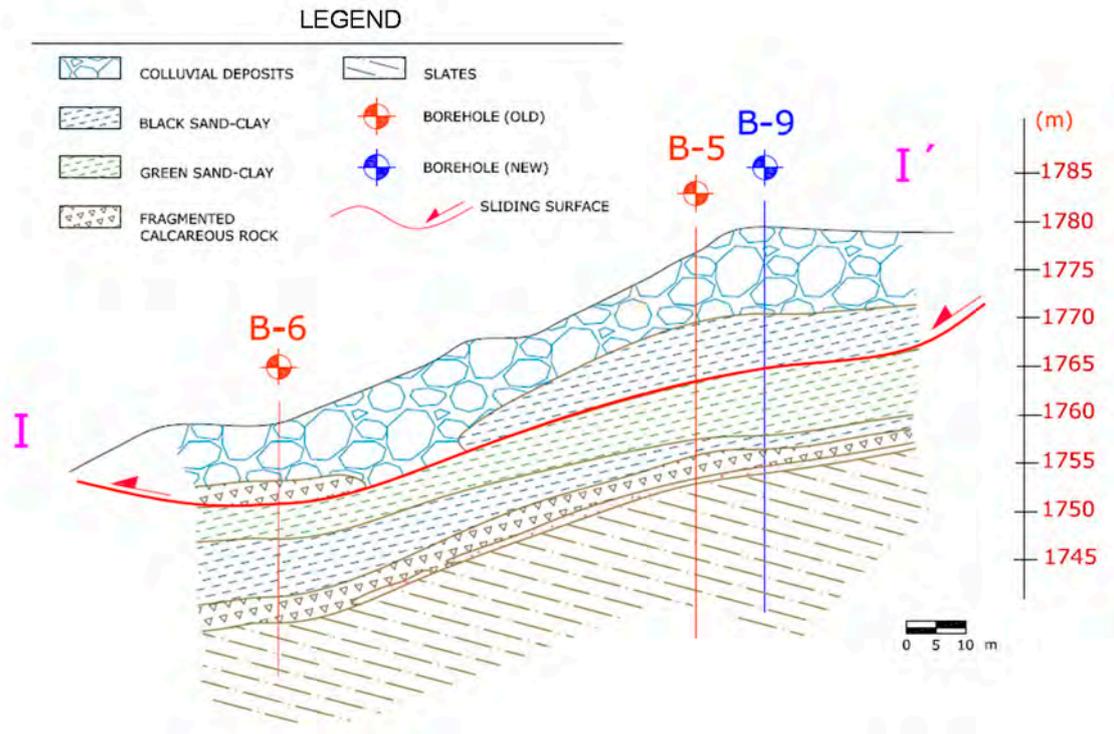
Data from boreholes, inclinometers and surface movements led to defining a failure surface located at depths between 5 m and 19 m (see Figure 5), with a fairly planar shape and with greater curvature in the slope toe area. The failure surface daylights on the slope and is observed on the ground surface (at both the slope head and toe) as seen in Figure 6. Surface movements in the E-SE direction, topographically recorded during the previous geotechnical investigations [15], showed small movements on the head of the slope as well as on the excavated slope. Those movements ranged between 1 cm and 3 cm, with movements in the northern area being slightly inferior to southern areas.

Figure 5. Geotechnical profile I-I' (see Figure 2) of the area under study; failure surface detected is shown in red.

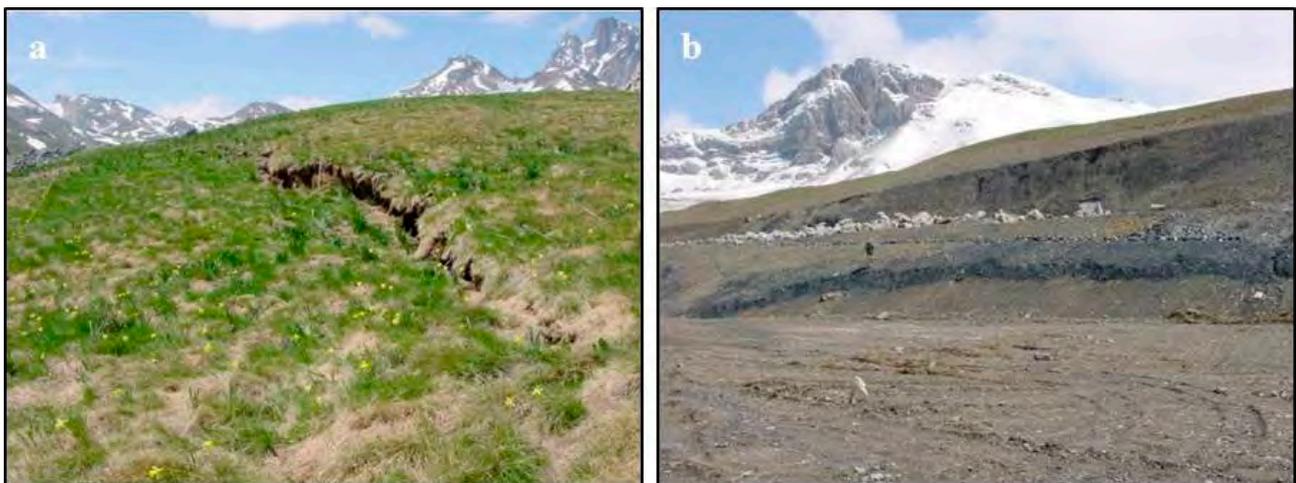
Figure 6. Daylight of the failure surface: (a) stress crack; (b) warped plane morphology.

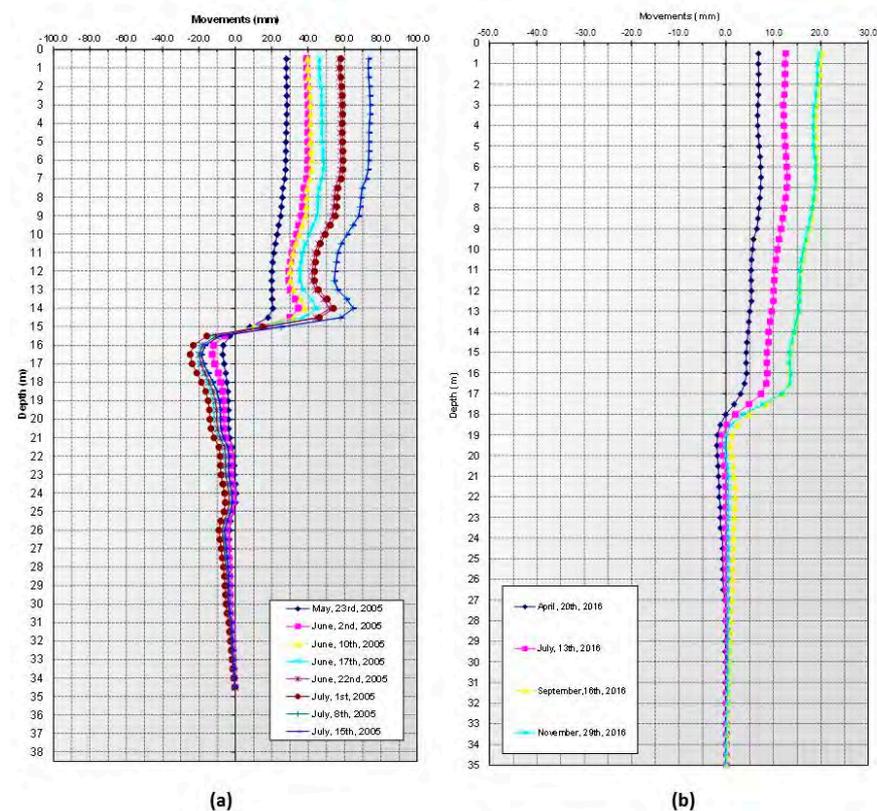
Inclinometers revealed the development of the failure surface mainly through the sandy clay materials in contact with the fragmented calcareous rock. An example of inclinometer data obtained in the previous study [15] and new geotechnical investigations

Figure 7. Inclinometers records: (a) Inclinometer placed in borehole B-5, reprinted with permission from ref. [15], Copyright Year 2005, Copyright Owner's F.J. Torrijo (old geotechnical investigations [15], conducted in 2005); (b) Inclinometer placed in borehole B-9 (new geotechnical investigations, conducted in 2016).

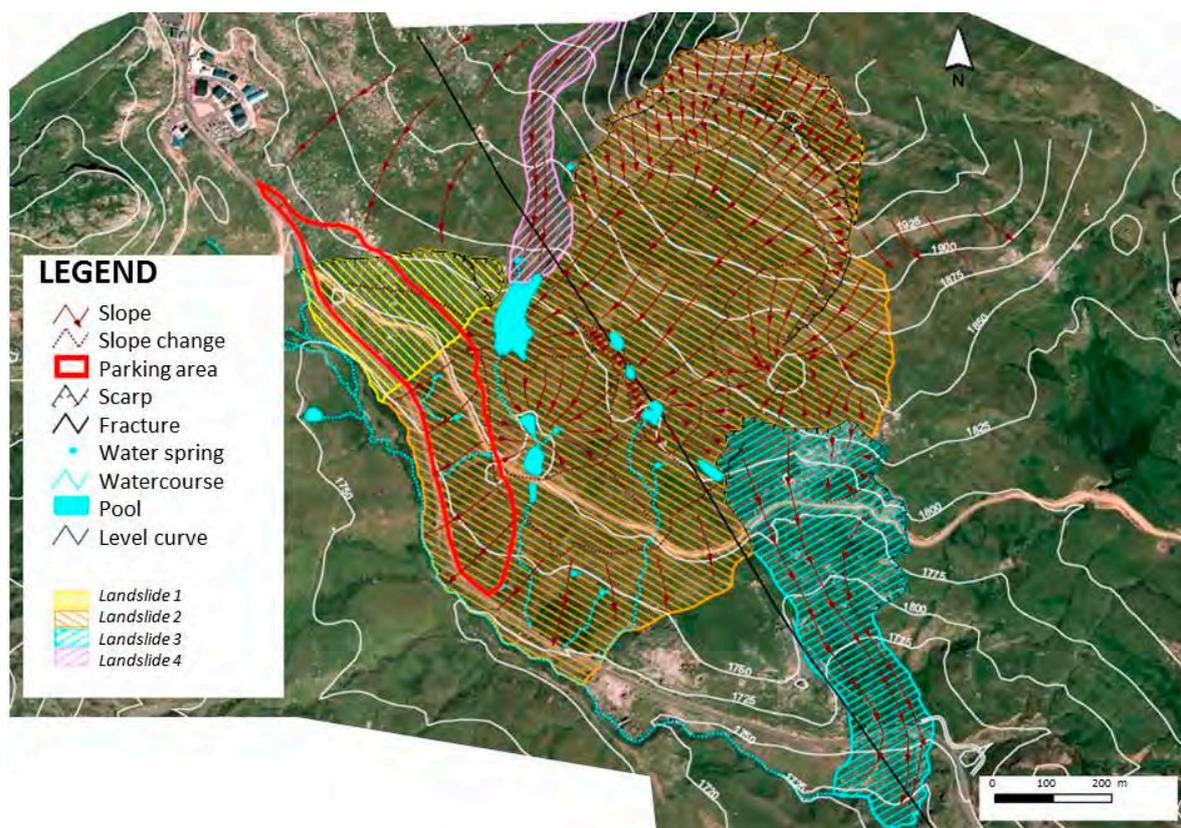
Topographical works developed during the previous investigation [15] detected the existence of three main landslides in the area under study (landslides, 1, 2 and 3 in Figure 8). This information was confirmed by the DinSAR data [21,22]. One of those landslides (landslide 3) was not affected by any anthropogenic activity (i.e., was not the consequence of the parking excavation) and was an extremely slow movement [46,47] with an estimated average velocity [22] of approximately 16 mm/year and affected by seasonal rainfalls. The second landslide (landslide 1) was activated by the parking excavation and corresponds to the slope movement under study. Its movement rate, estimated by the auxiliary DGPS campaign of approximately 0.1 m/year, meant it was not possible to compute its velocity with the DinSAR technique [22]. The third landslide (landslide 2) was located next to the previous one, was also activated by the parking excavation and its average velocity was estimated [22] at approximately 25 mm/year. The ALOS PALSAR differential interferometry [24] was also applied to this last landslide, obtaining similar results.

Figure 8. Main landslides detected in the area under study.

DGPS measurements [14], conducted after performing the stabilization work on the slope (i.e., landslide 2 according to Figure 8), showed that maximum displacement rates were around 1 mm/day in the summer while rates increased up to 2 mm/day in the fall. Those measurements also identified that the landslide's most active part was an area located below the main scarp. GB-SAR technique discovered that the landslide displacements were fairly linear in time, although slight differences were observed due to daily rainfall variations. Generally, an acceleration of the landslide occurs when rainfall events take place.

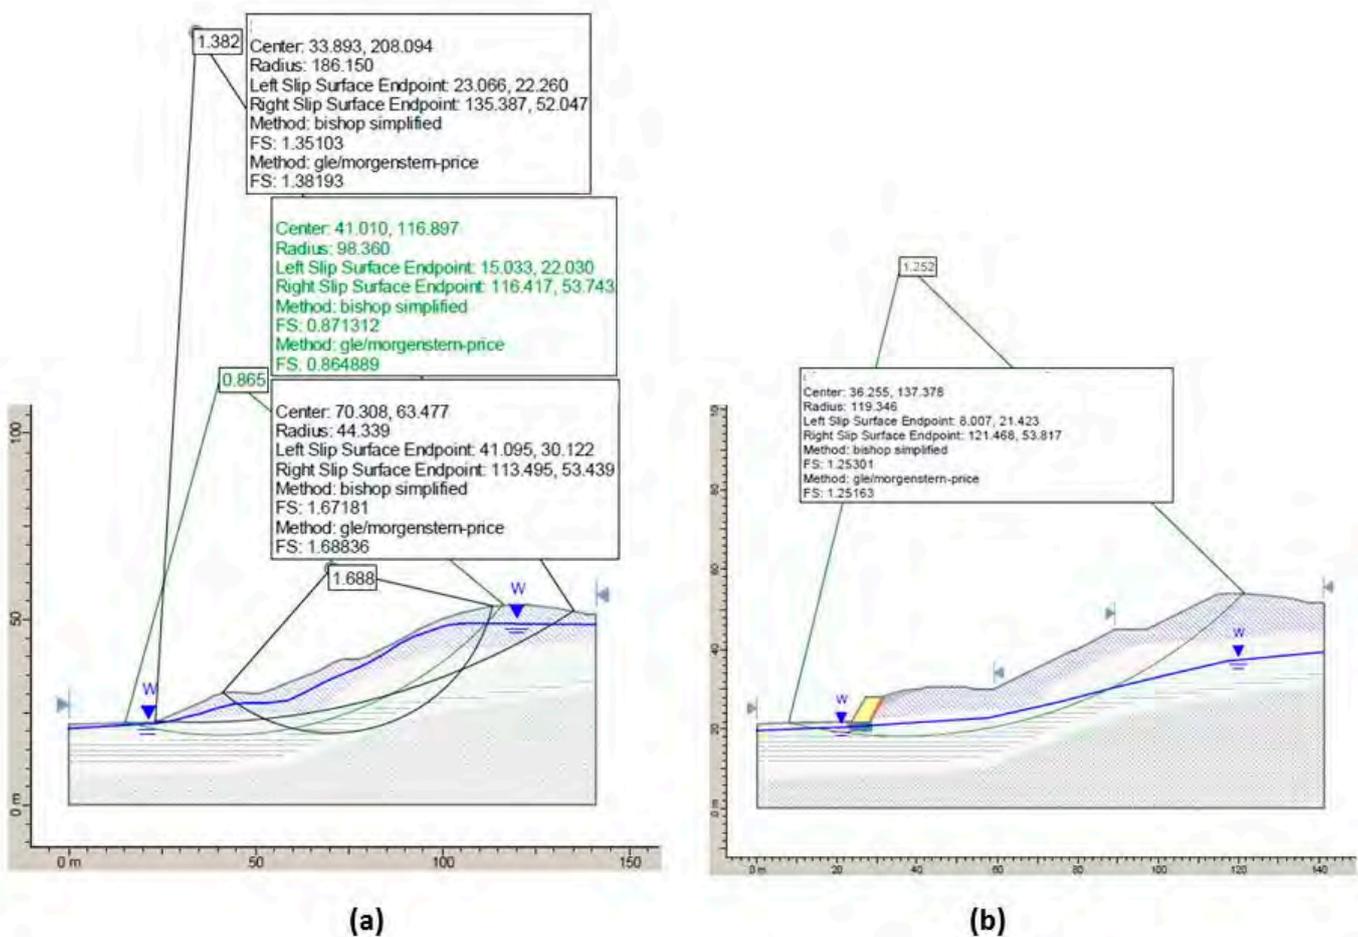
Under natural conditions, once the parking area was excavated and prior to implementing any corrective measure, profile I-I', according to Figures 2 and 5, was found to be the most unfavourable profile. Without taking into account the seismic component, the safety factor at that profile resulted in 0.86. That confirms the existence of the landslide produced by the parking excavation and the subsequent movement of the slope. It should be mentioned that this landslide was a first-time failure, not a reactivation of a previous one. When the seismic action was taken into account, a safety factor of 0.59 was obtained for the same profile (i.e., about 30% lower).

The analyses were run again introducing the projected measures and considering the final stage of the projected slope. The water table was located following the data obtained from the inventory of water points carried out in the new investigations and considering that the capacity of California drains is greater than the recharge of the aquifer (an average level was considered since the water table depends on rainfalls, see the next section). Profile I-I' was still found to be the most unfavourable. In this case, the safety factor without taking into account the seismic component increased to 1.3; taking into account the seismic acceleration, the safety factor was 1.1 (about 15% lower). That result indicates that the slope is stable and the landslide is expected to be under control with the projected measures. Figure 9 shows the results computed by the Bishop's method for profile I-I' before and after implementing the stabilization measures using the software Slide v5.028 [48].

Figure 9. Safety factor analyses of profile I-I' (see Figure 2): (a) slope in its natural state after the parking excavation; (b) slope state after implementing the stabilization measures.

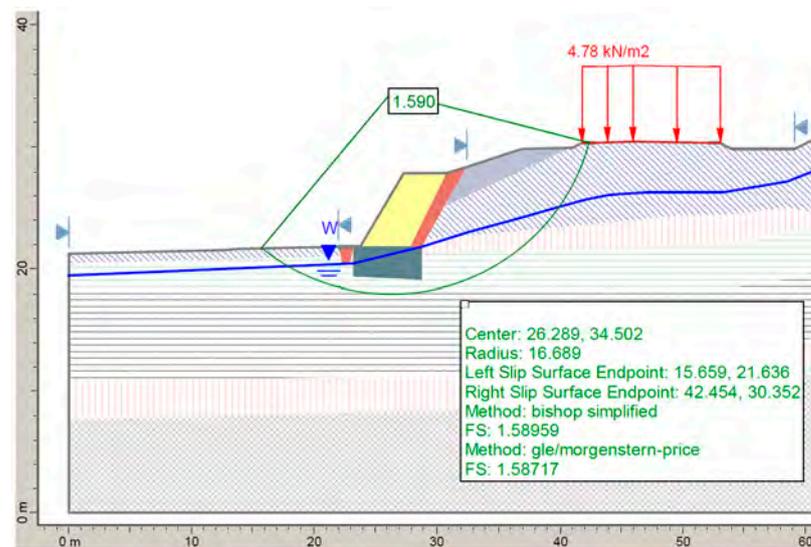
instance, Figure 10 shows a stability analysis carried out by both the Bishop [44] and the Morgenstern–Price [45] methods taking into account only the area around the toe wall. The safety factor obtained was nearly 1.6 in both cases, about 23% and 45%, respectively, greater than that computed in the scenario considered in Figure 9b. This may have led to an assumption that the installation of that wall was the unique corrective measure needed, which resulted in it not being enough for controlling the hillside movement.

Figure 10. Stability analysis considering the projected wall alone.

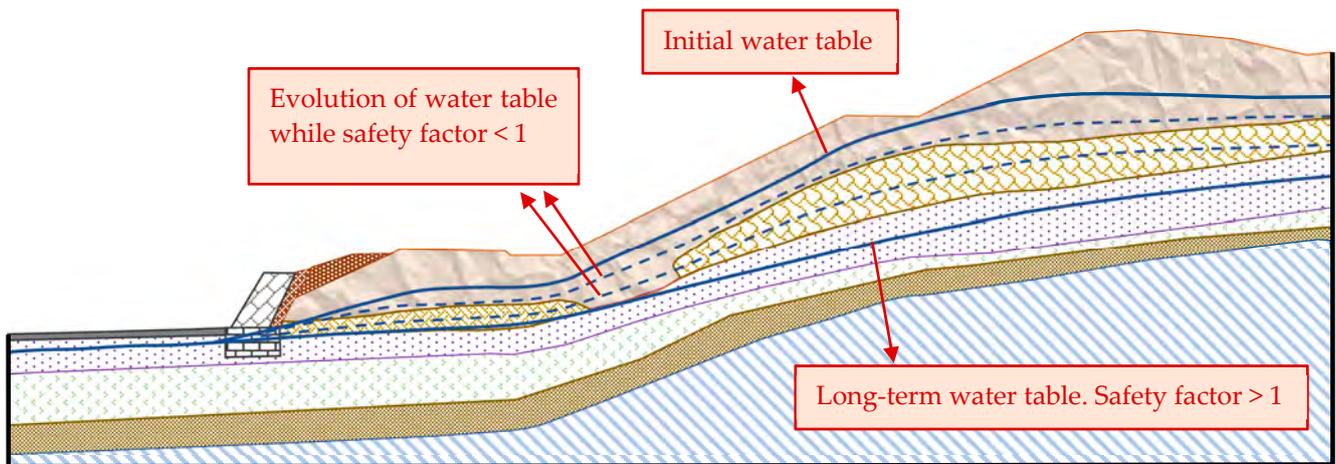
As a consequence, the water table lowering does not only depend on the drainage capacity and the efficiency of the Californian drain but also on the weather and the annual recharge (Figure 11). As a result, the drainage of the slope needs time. During that time, the slope is expected to have a safety factor lower than 1.0, which explains the movement of the slope recorded by the different investigations (in fact, the safety factor increased from the situation depicted in Figure 9a to the one given in Figure 9b). Thus, although the future solution in the long term will be stable, attaining this situation will need to wait for some time during which the slope will exhibit unstable behaviour.

Figure 11. Expected evolution of the water table and its qualitative relationship with the safety factor.

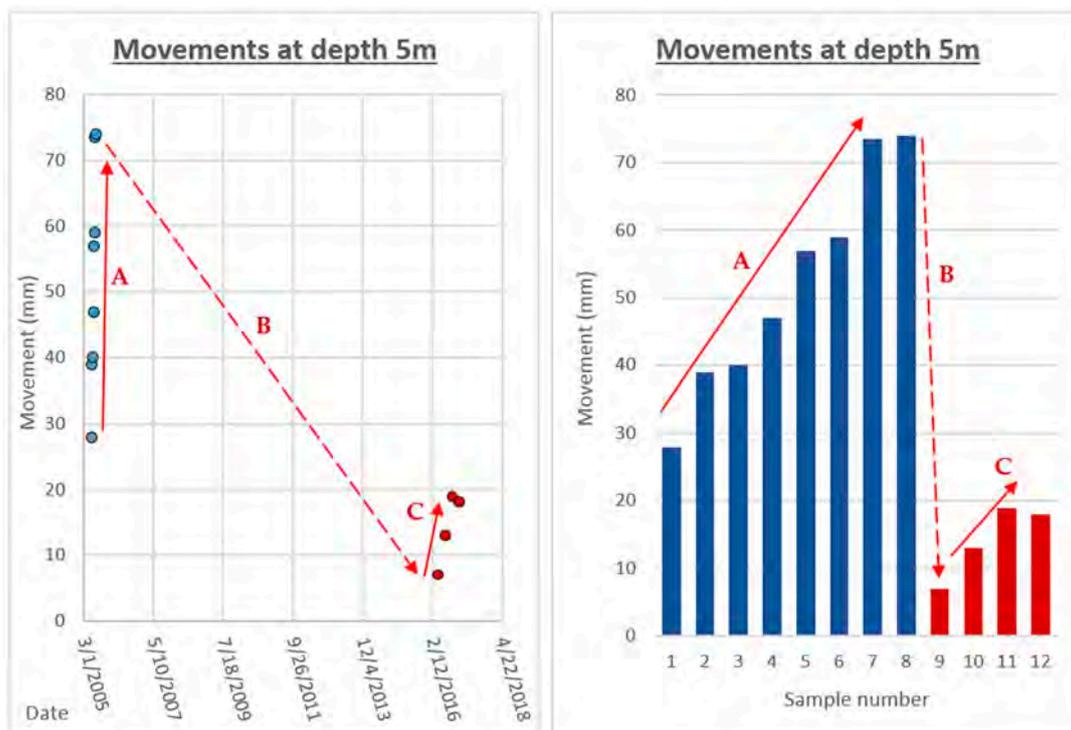
Figure 12. Evolution of the movements at a depth of 5 m. Long-term trend. The movements are represented in blue for borehole B5 (installed in year 2005) and brown for borehole B9 (installed in year 2016), Date given in Day/Month/Year. Letter A refers to the fast increment in deformations in 2005; B refers to the reduction of deformations between 2005 and 2016; C refers to the acceleration of deformations registered in 2016.

Figure 12 shows that, in 2005, the deformations were increasing and the slope was moving faster (A). Between 2005 and 2016 the deformations were greatly reduced, so the landslide was stopping (B). Finally, according to 2016 records, the slope continued to accelerate; from April to September the movement evolved from 5 to 20 mm, although from

September to November it seemed to stabilize (C). This acceleration in a given year was also observed in 2005 for the same period, April to September. That period corresponds to the spring season when precipitations normally occur in the area under study together with the snowmelt phenomenon [49]. Thus, these results confirm the influence of the water table in the landslide stability, the long-term tendency observed in the evolution of the slope movement and the long time needed to attain drainage of the ground mass (Supplementary Materials).
