A Case Study of a Large Unstable Mass Stabilization: “El Portalet” Pass at the Central Spanish Pyrenees

Abstract: This case study presents the engineering approach conducted for stabilizing a landslide that occurred at “El Portalet” Pass in the Central Spanish Pyrenees activated due to the construction of a parking lot. Unlike common slope stabilization cases, measures projected here were aimed at slowing and controlling the landslide, and not completely stopping the movement. This decision was taken due to the slow movement of the landslide and the large unstable mass involved. The degree of success of the stabilization measures was assessed by stability analyses and data obtained from different geotechnical investigations and satellite survey techniques such as GB-SAR and DinSAR conducted by different authors in the area under study. The water table was found to be a critical factor in the landslide’s stability, and the tendency of the unstable slope for null movement (total stability) was related to the water table lowering process, which needs more than 10 years to occur due to regional and climatic issues. Results showed a good performance of the stabilization measures to con

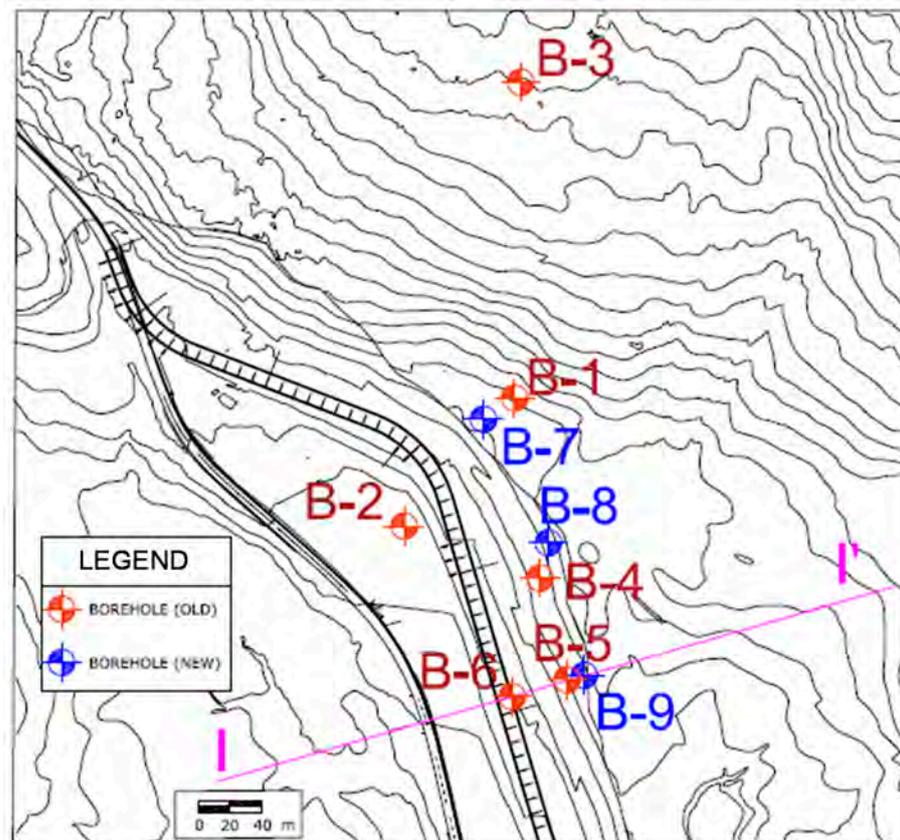
Previous geological–geotechnical investigations [15] conducted in 2005 consisted of six boreholes (location is shown in Figure 2) with depths between 24 m and 40 m. Standard Penetration Tests (SPT) were performed on each borehole when crossing soils and very weathered rocks, with a frequency of about 3 m. Disturbed and undisturbed samples were extracted from each level identified. Laboratory tests conducted on such samples included general identification tests (e.g., grain size, Atterberg limits, unit weight) and mechanical tests (uniaxial compression strength on rocks and direct CD shear tests and triaxial CU tests on soils).

Inclinometers were installed on each borehole performed. Besides, topographical landmarks were placed along the hillside to measure surface movements. Attempts to locate landmarks were made next to the existing tension cracks on the head of the slope as well as in the excavated slope. Movements between pairs of landmarks were measured every 15 days and five measurement campaigns were carried out.

Figure 2. Location of the boreholes performed in the previous study [15] (“old” boreholes, conducted in 2005, reprinted with permission from ref. [15], Copyright Year 2005, Copyright Owner’s F.J. Torrijo) and the new geotechnical investigation (“new” boreholes, conducted in 2016); profile I-I’ relates to Figure 5.

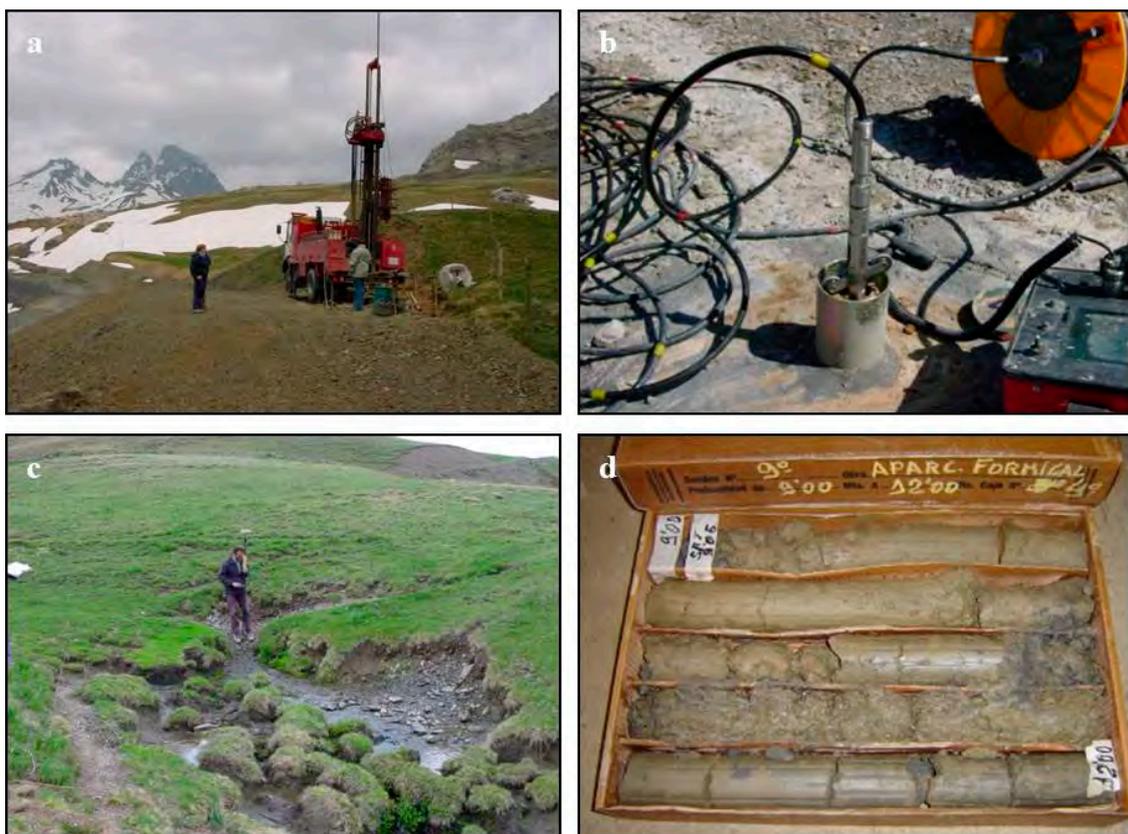
In 2016, approximately 10 years after conducting the stabilization works of the slope, three new boreholes were performed (Figure 4a) at the area under study. Those boreholes attained a depth between 30 m and 45 m and were performed close to those executed in the previous field investigation (see Figure 2). On each borehole, SPT tests were performed in soils and very weathered rocks, with a frequency of about 3 m. Disturbed samples were extracted from each level found and general identification laboratory tests were carried out (grain size, Atterberg limits and unit weight).

Similar to the actions performed in the previous geological–geotechnical investigation, inclinometers were installed on the new boreholes (Figure 4b). Besides, a new inventory of water points was carried out along the entire hillside (Figure 4c).

Figure 4. New geotechnical investigation works: (a) Borehole performance; (b) Inclinometer installation; (c) Inventory of water points; (d) Example of the Quaternary material obtained in the boreholes.
